September 20, 2007

06-1118-063-7

**RE: 2006 TAILINGS DAM INSPECTION
LACNOR-NORDIC TAILINGS MANAGEMENT AREA AND BUCKLES CREEK**

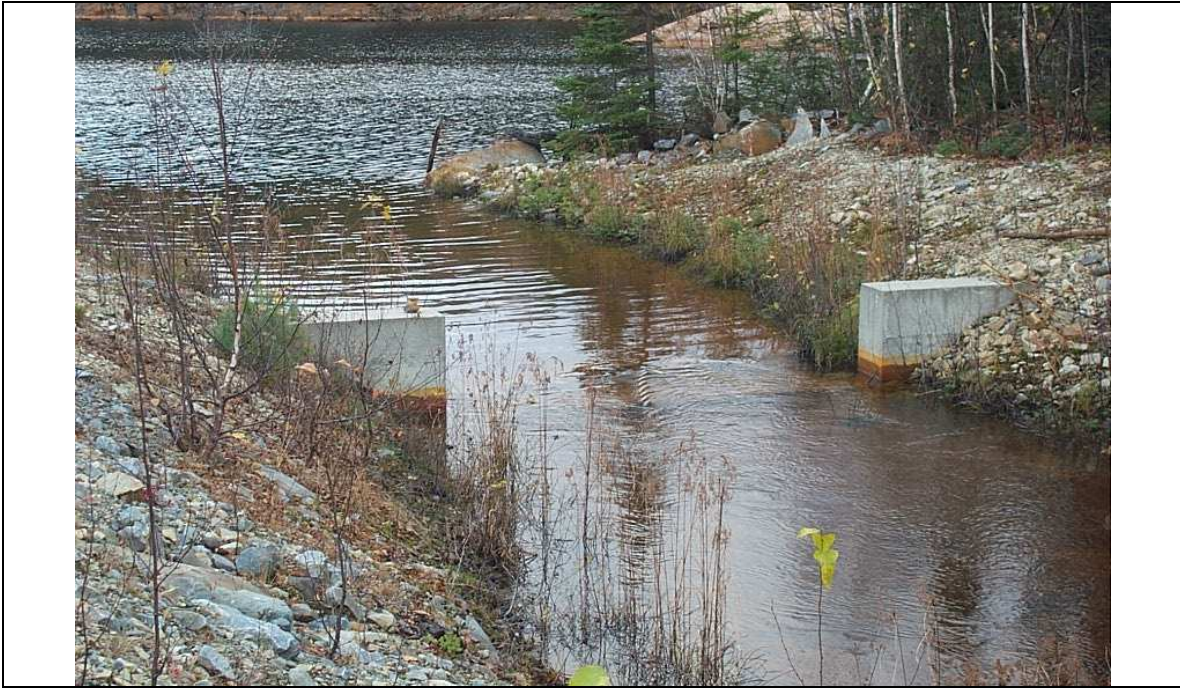
Photo 1: Tailings pond spillway inlet – Lacnor TMA

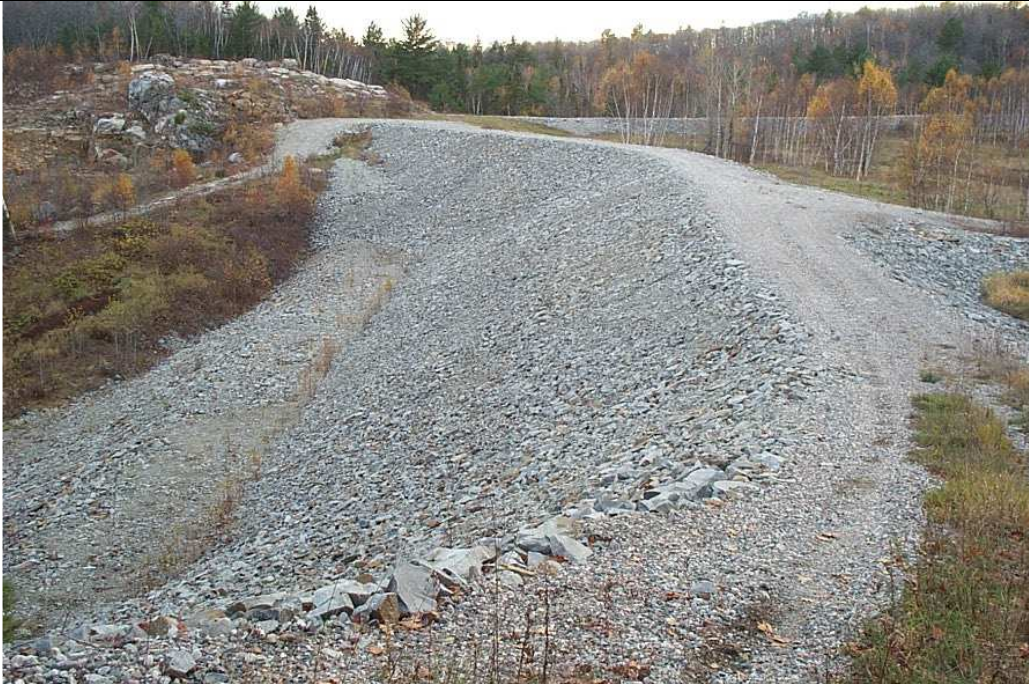
Dam A is in good condition. Piezometric water levels observed in dam are consistent with historical trend.

Photo 2: Dam A – Lacnor TMA

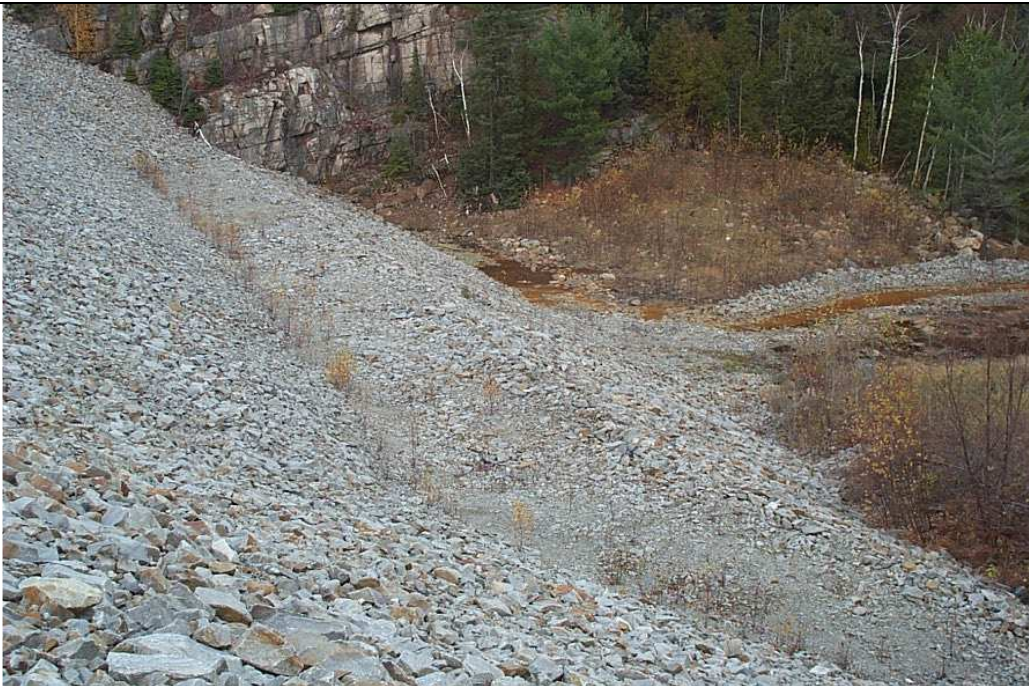
Photo 3: Dam A downstream slope – Lacnor TMA

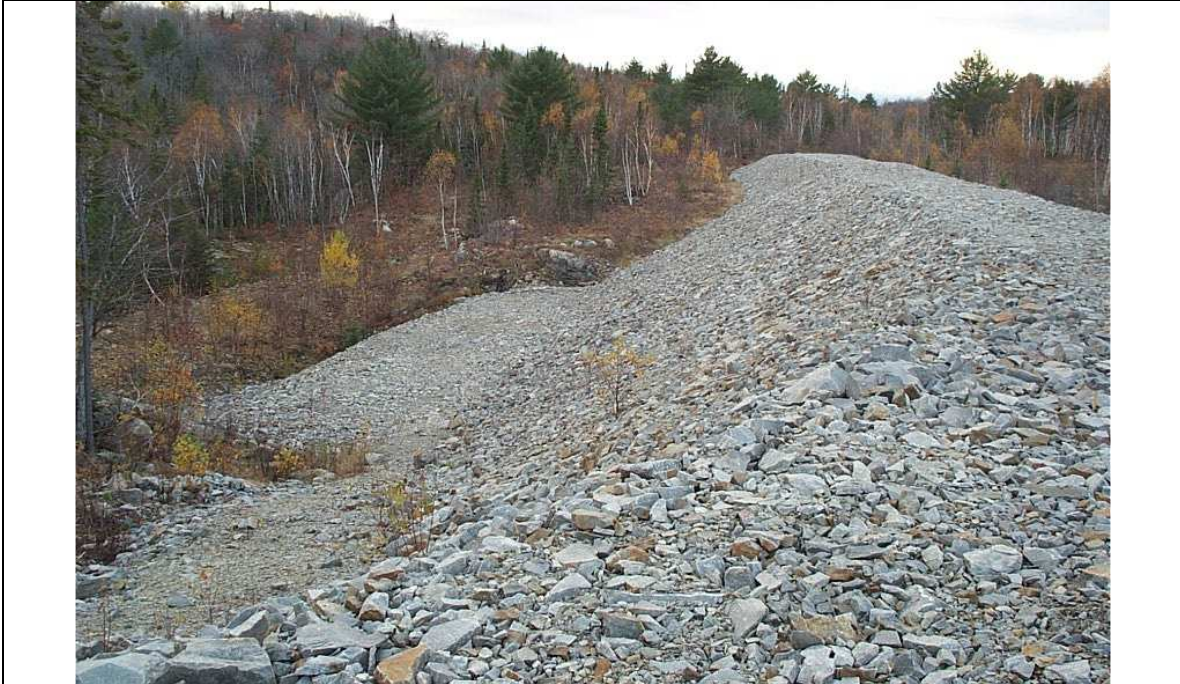
Dam B is in good condition.

Photo 1: Dam B – Lacnor TMA

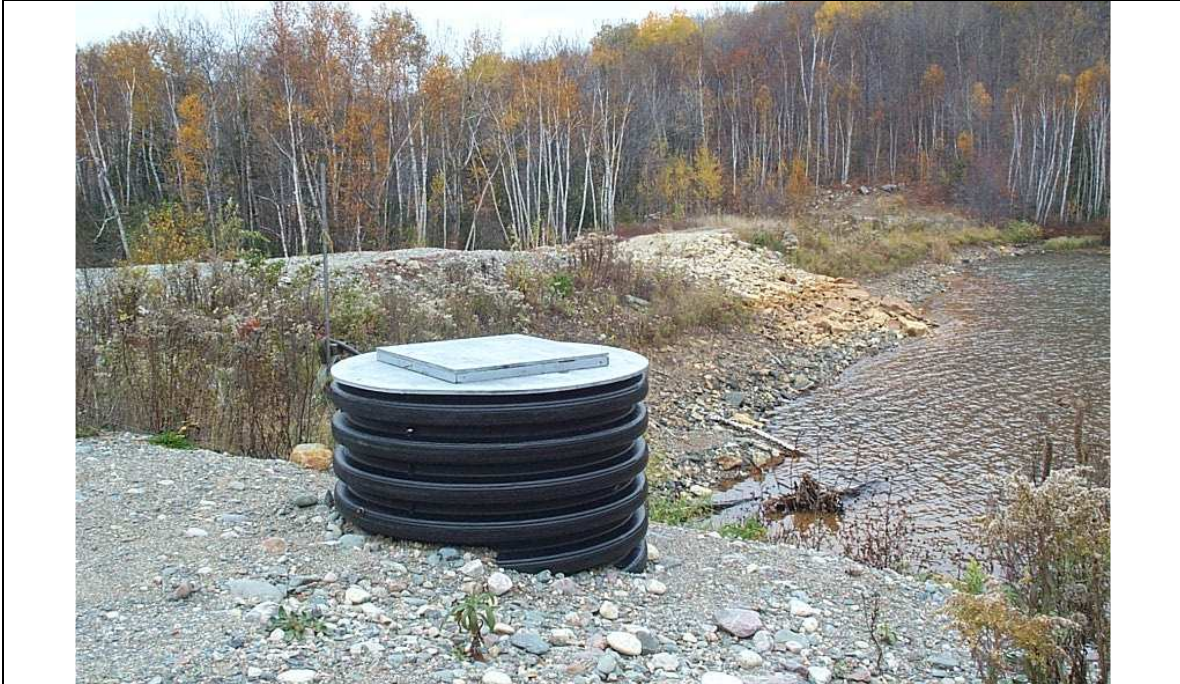
Photo 1: Dam A upstream view – Nordic TMA. Decant installed in 2006.

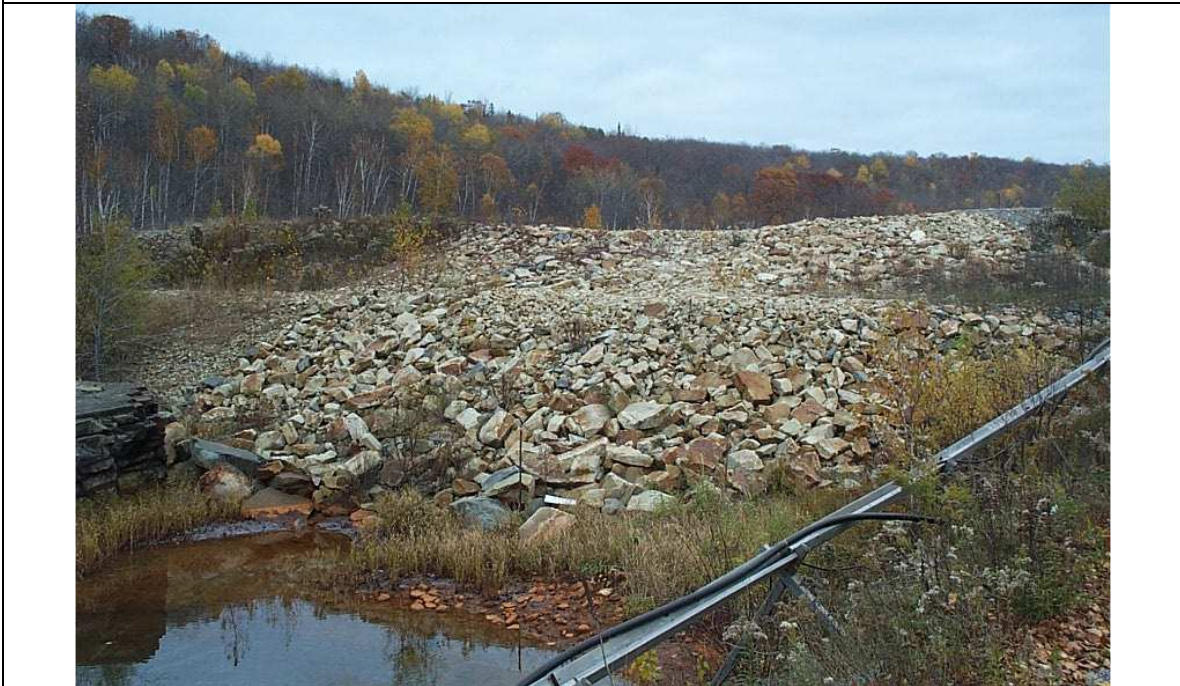
Photo 2: Downstream slope of Dam A – Nordic TMA

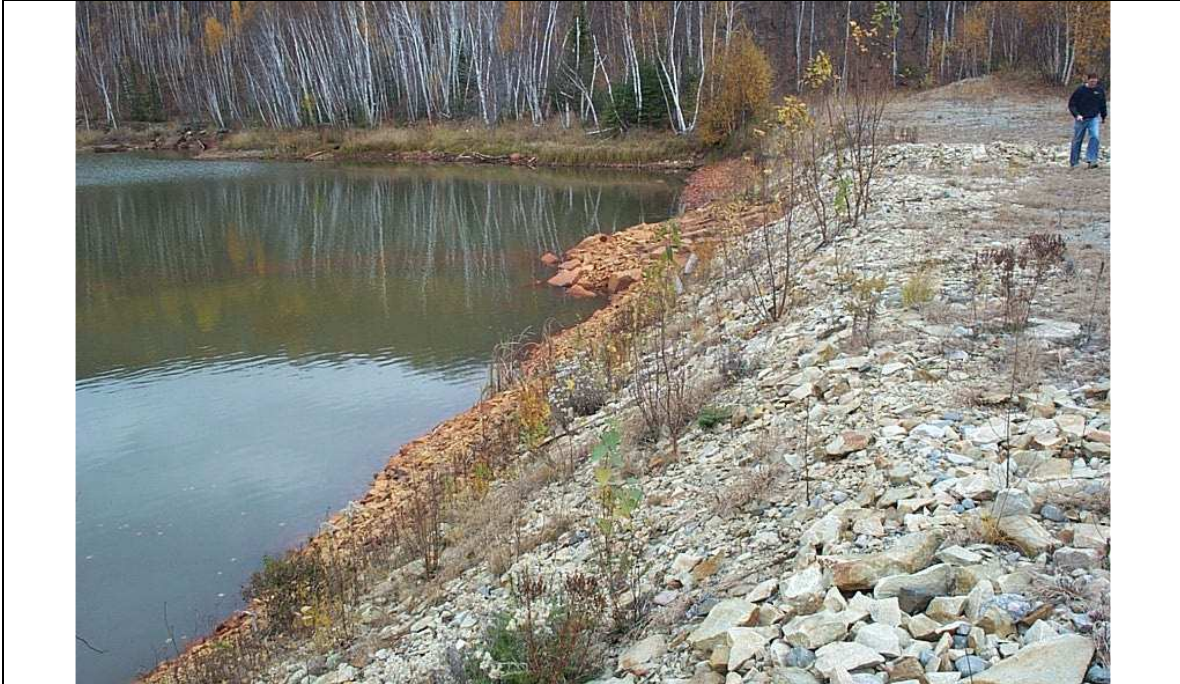
Photo 1: Dam B – Nordic TMA

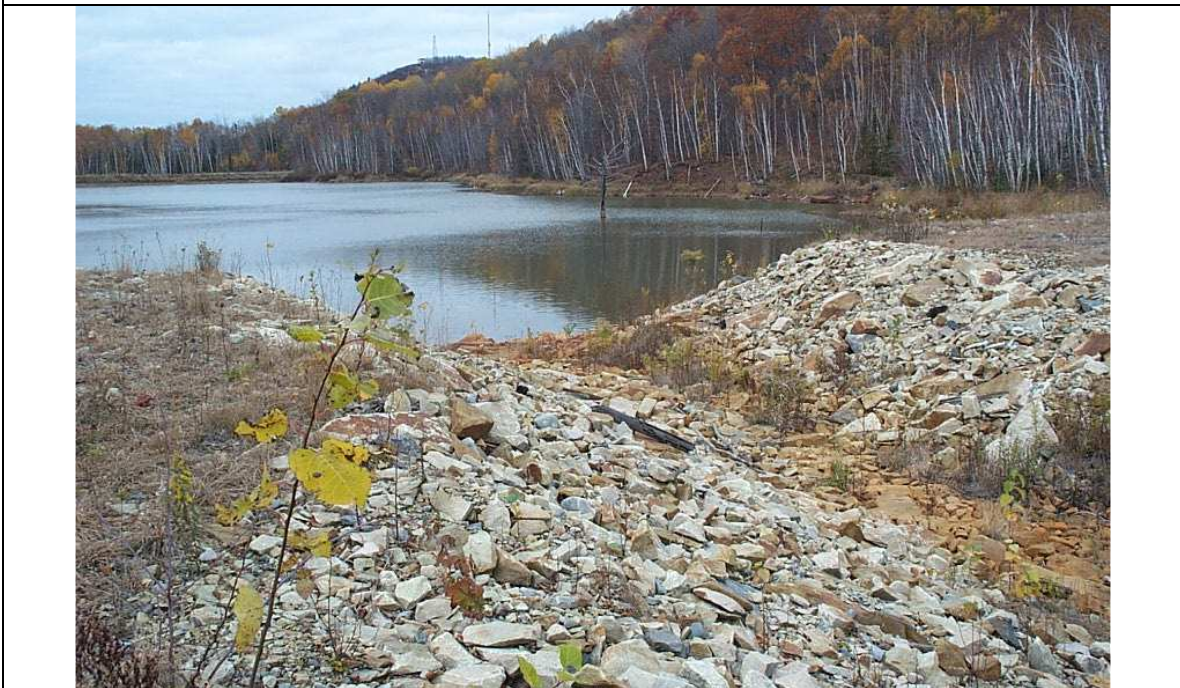
Photo 2: Spillway on Dam B – Nordic TMA

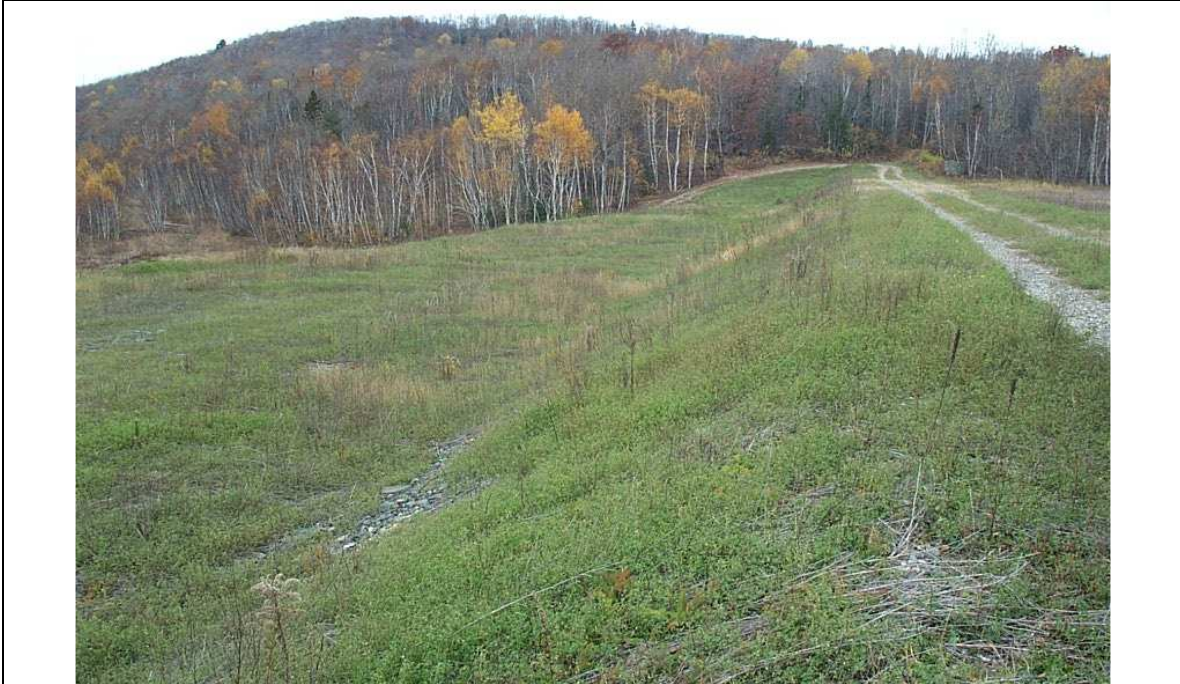
Photo 1: Dam C upper slope and toe buttress – Nordic TMA

DES indicated that no unusual maintenance was required for the Nordic TMA in the previous one year period. Clearing of vegetation on dams however, has not been carried out. It is recommended that the overgrown vegetation on Dam C and Dam F be removed.

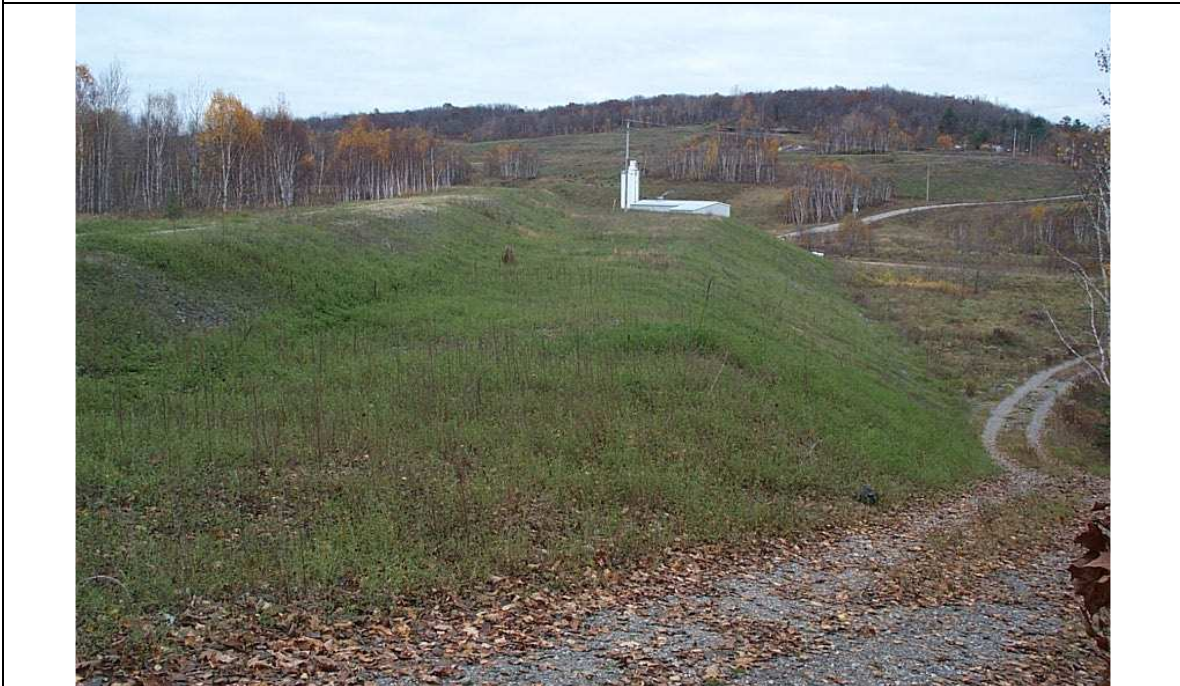
Photo 2: Dam C downstream slope – Nordic TMA

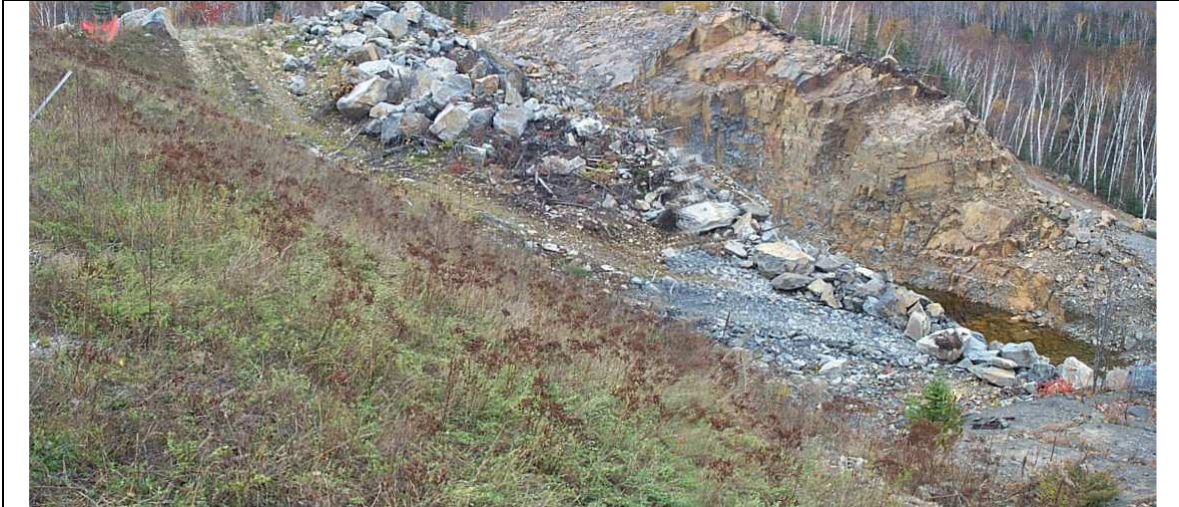
Photo 1: Dam D – Nordic TMA

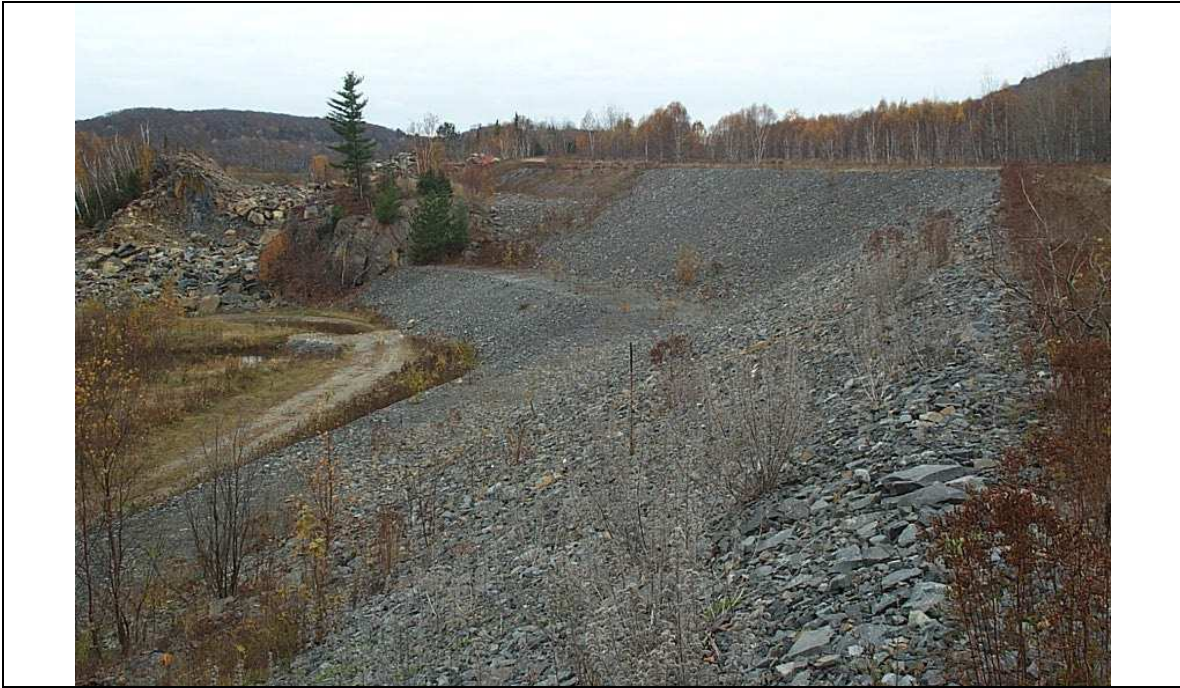
Photo 1: Dam E - Nordic TMA

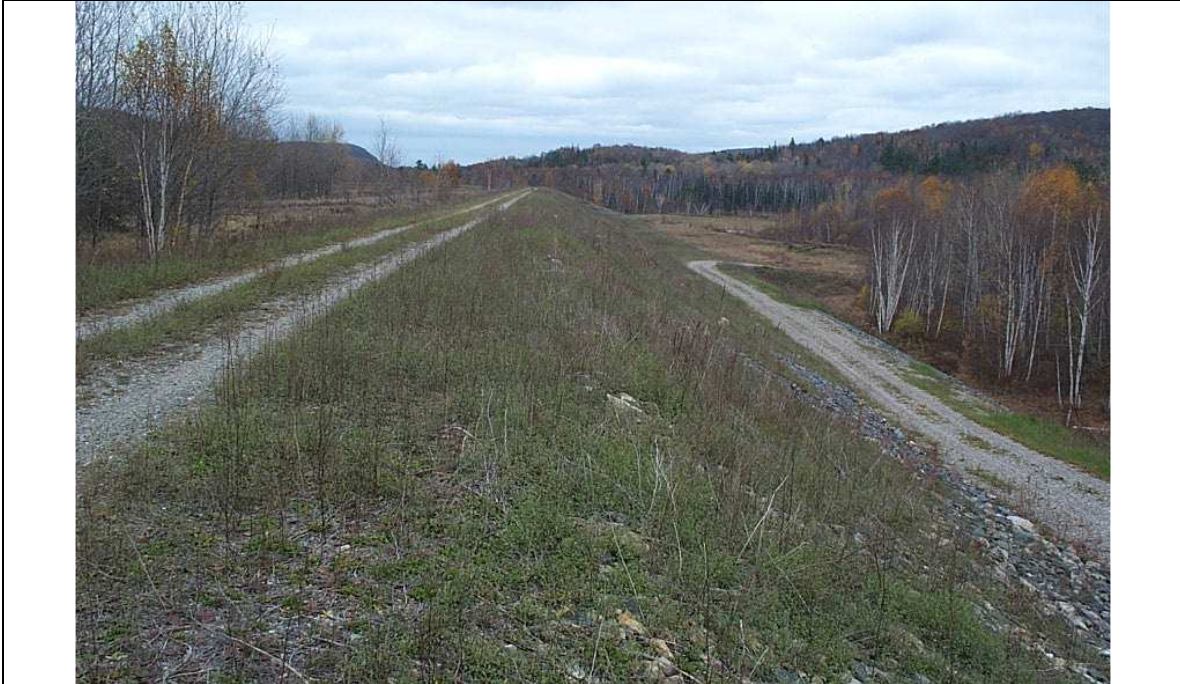
Photo 1: Dam F south arm – Nordic TMA

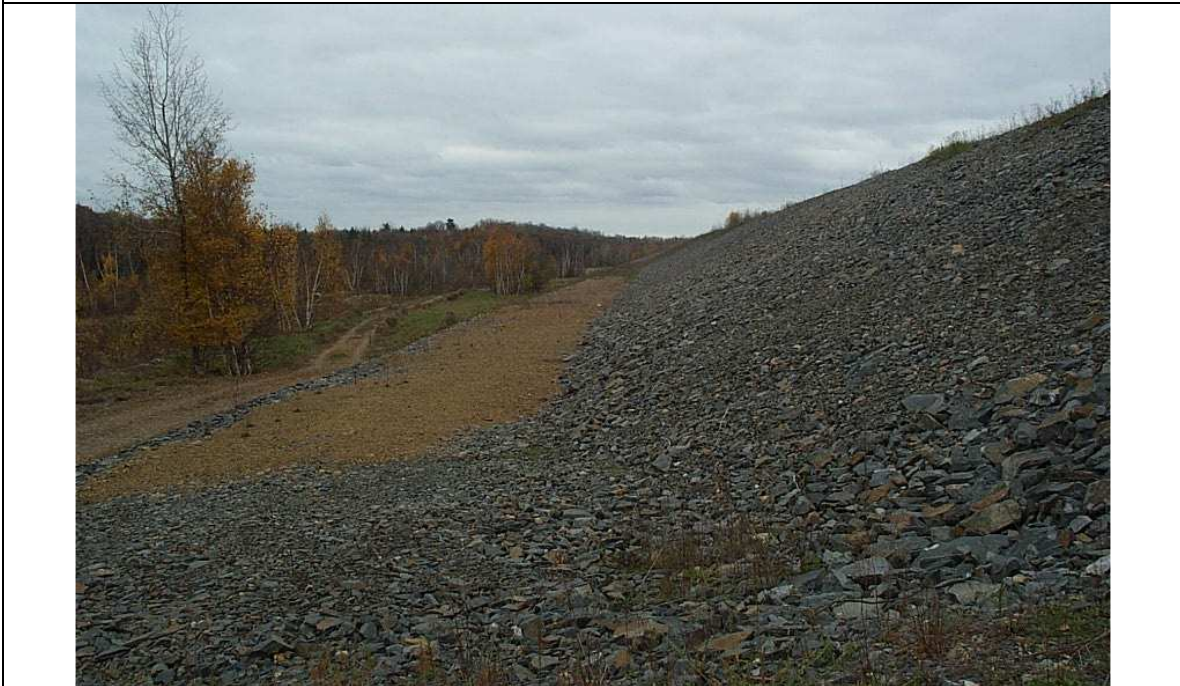
Photo 2: Dam F downstream slope looking from spillway – Nordic TMA

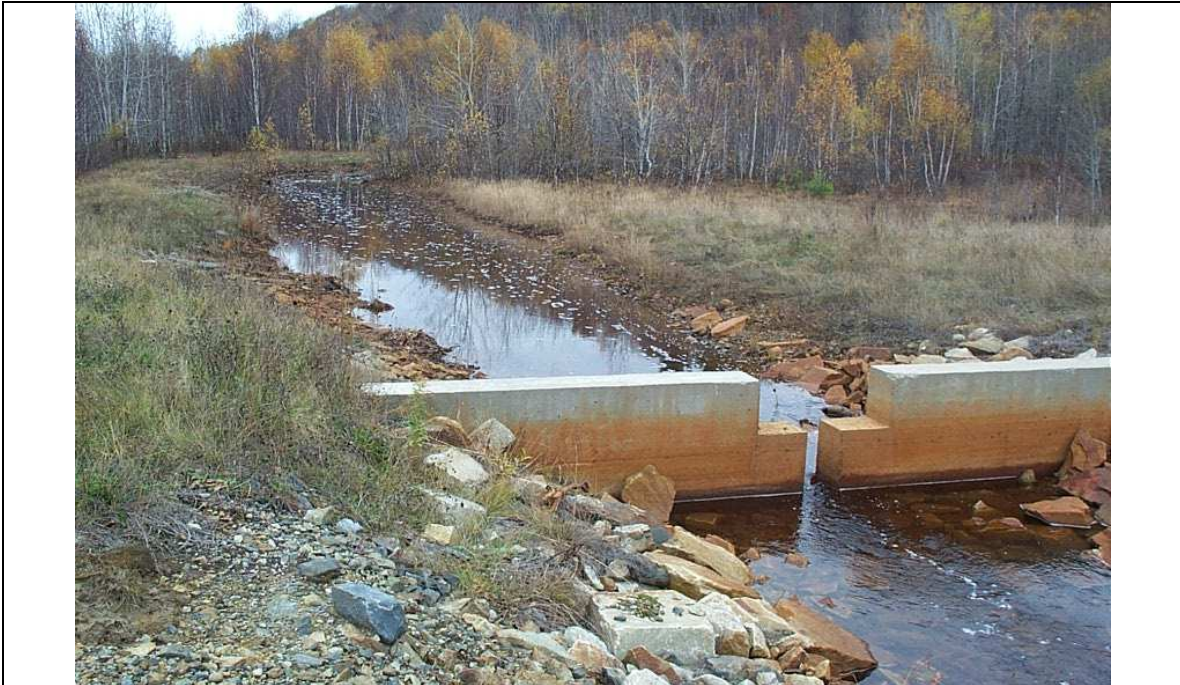
Photo 3: Dam F spillway flow control structure – Nordic TMA

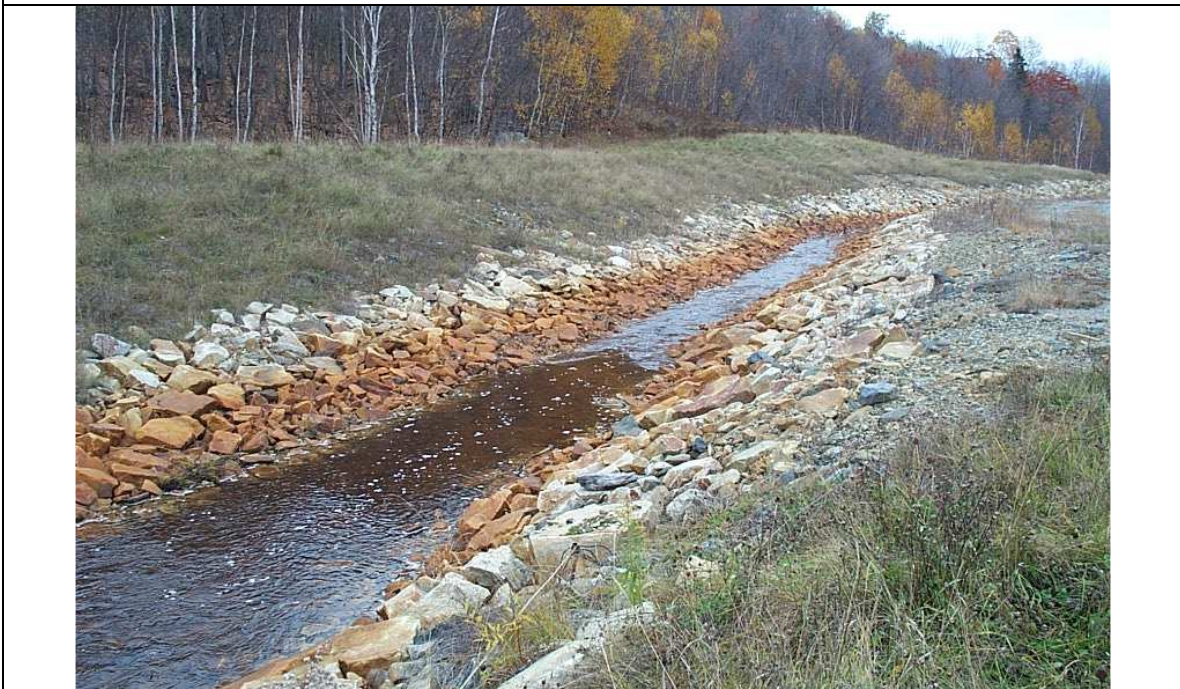
Photo 4: Dam F spillway outlet channel – Nordic TMA

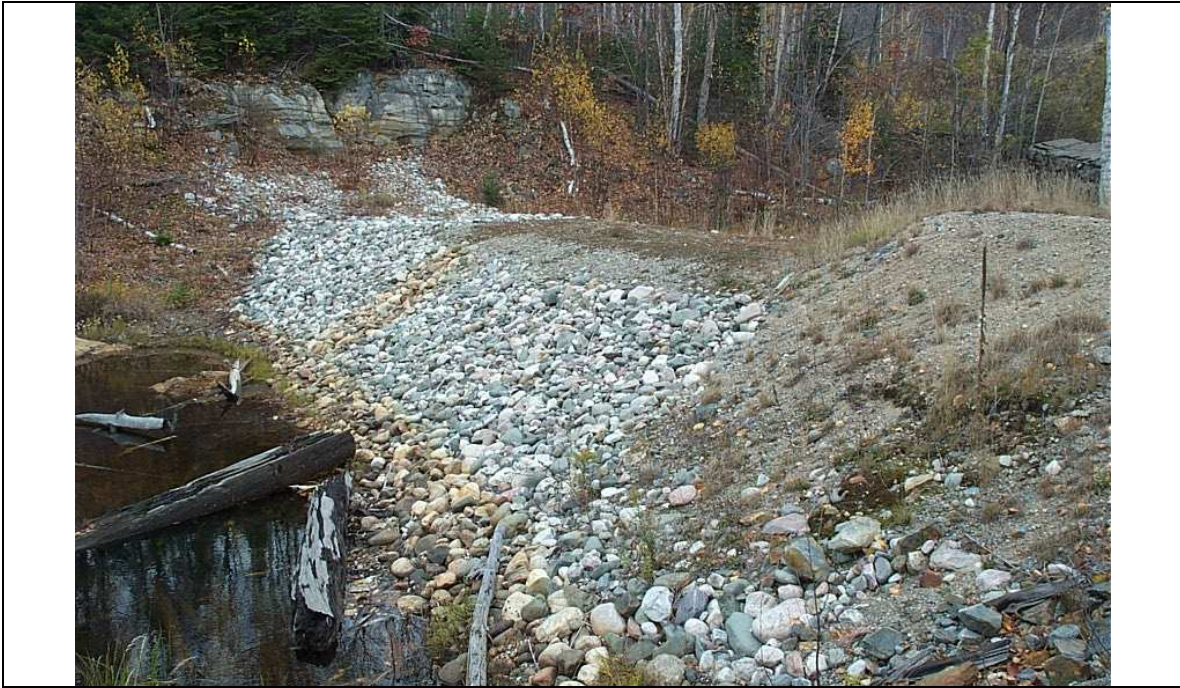
Photo 1: West Seepage Collection Pond Dam – Nordic TMA

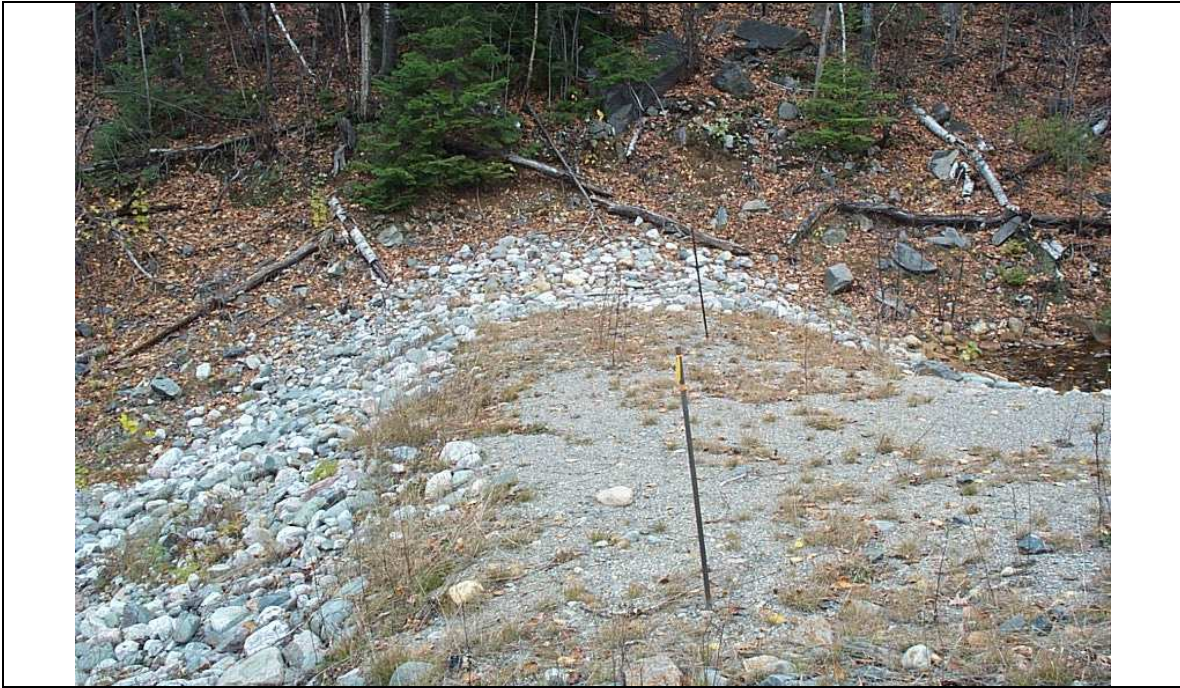
Photo 1: East Seepage Collection Pond Dam – Nordic TMA

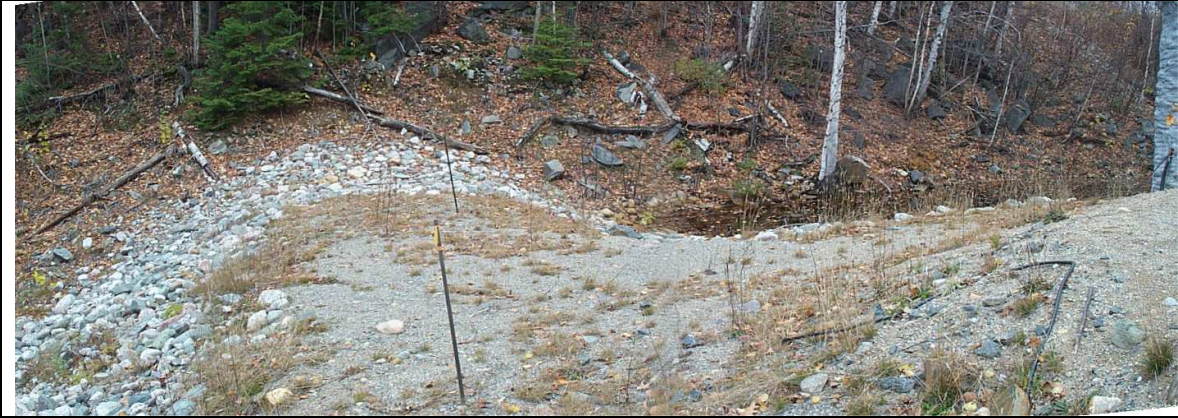
Photo 1: East Seepage Collection Pond Dam – Nordic TMA

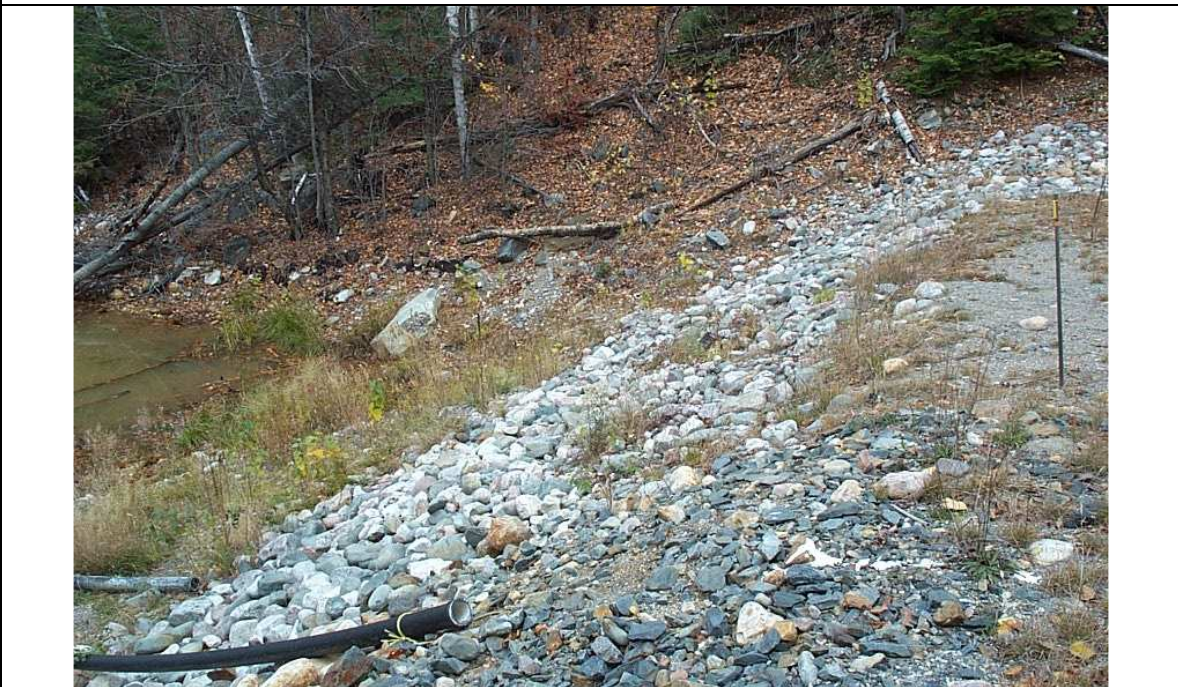
Photo 2: Downstream slope of dam – Nordic TMA

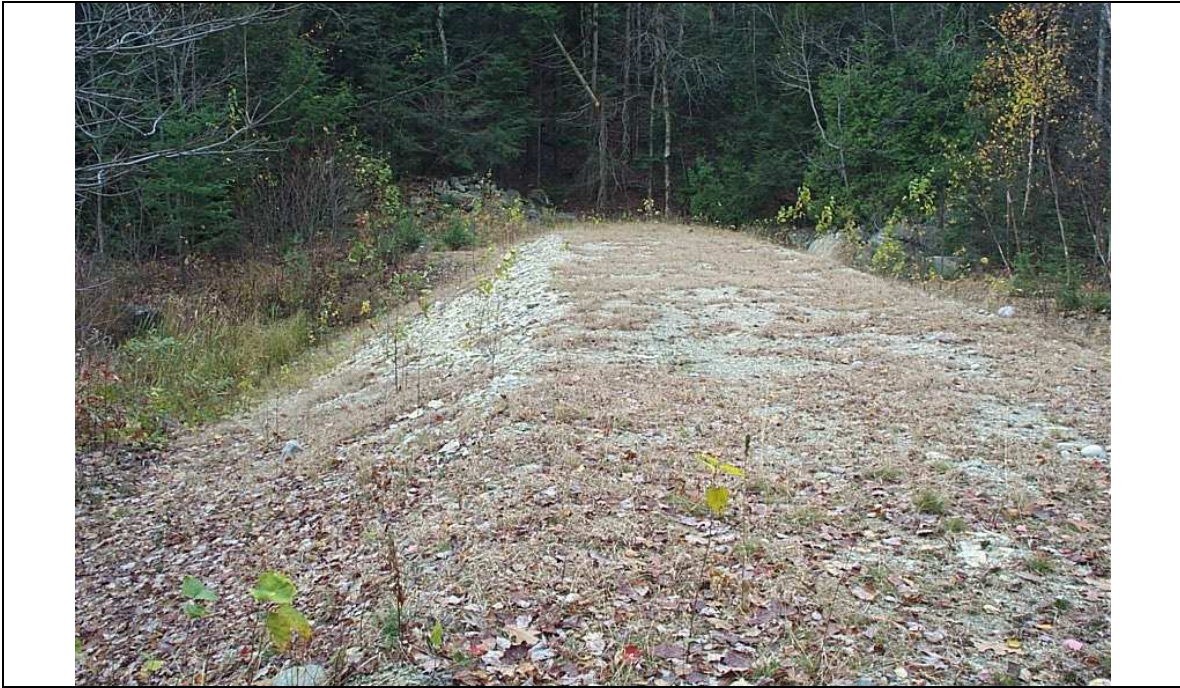
Photo 1: Nordic Settling Pond Berm – Nordic TMA

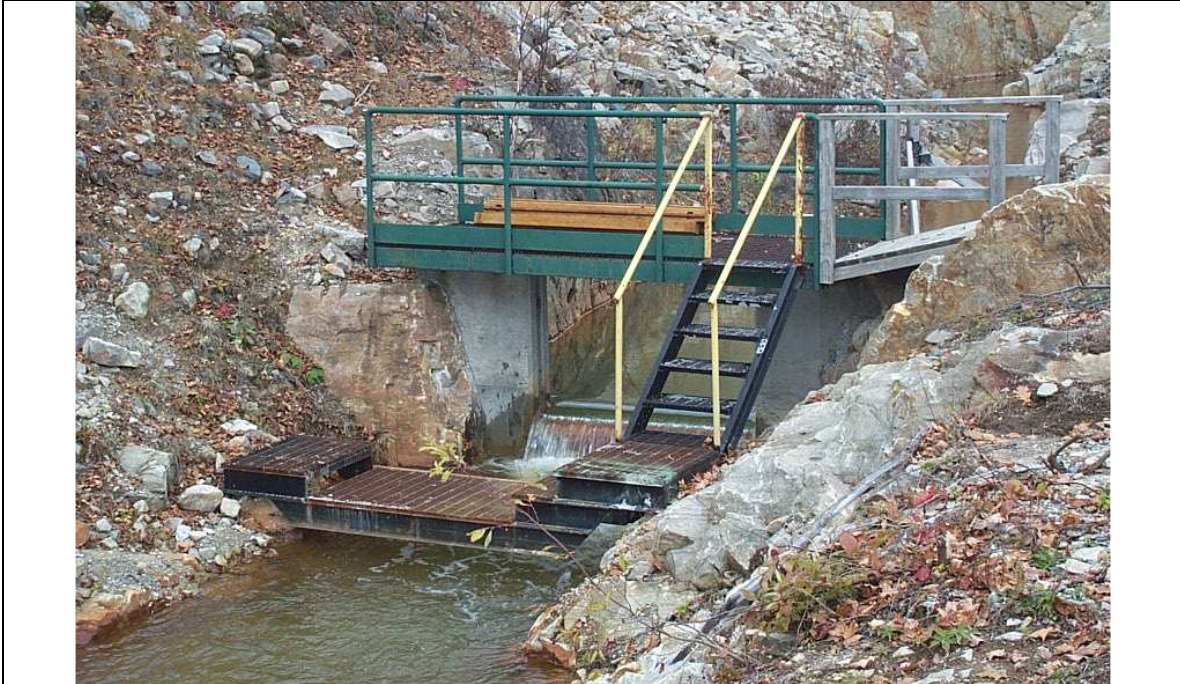
Photo 1: Nordic Settling Pond control structure

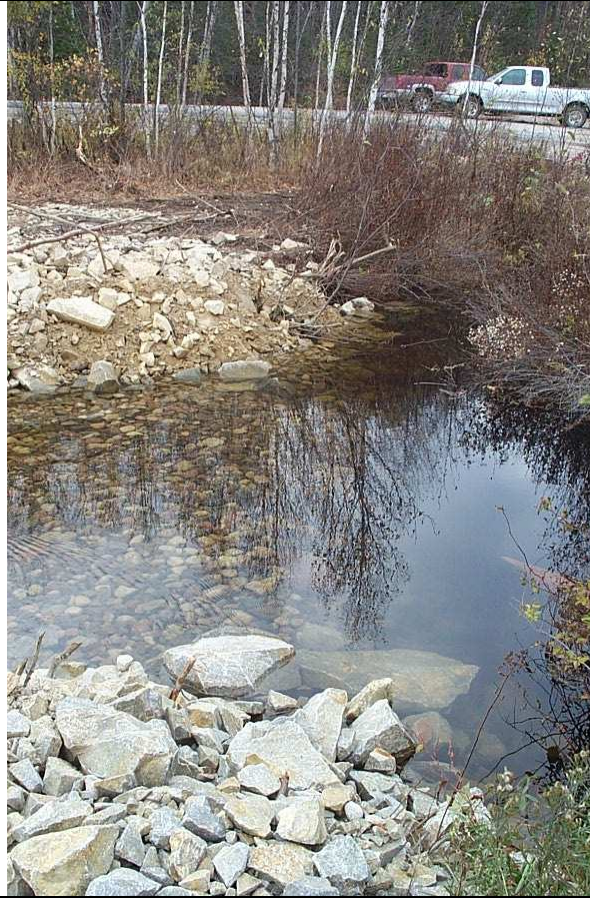
Photo 1: Cofferdam on Buckles Creek in placement of an old beaver dam

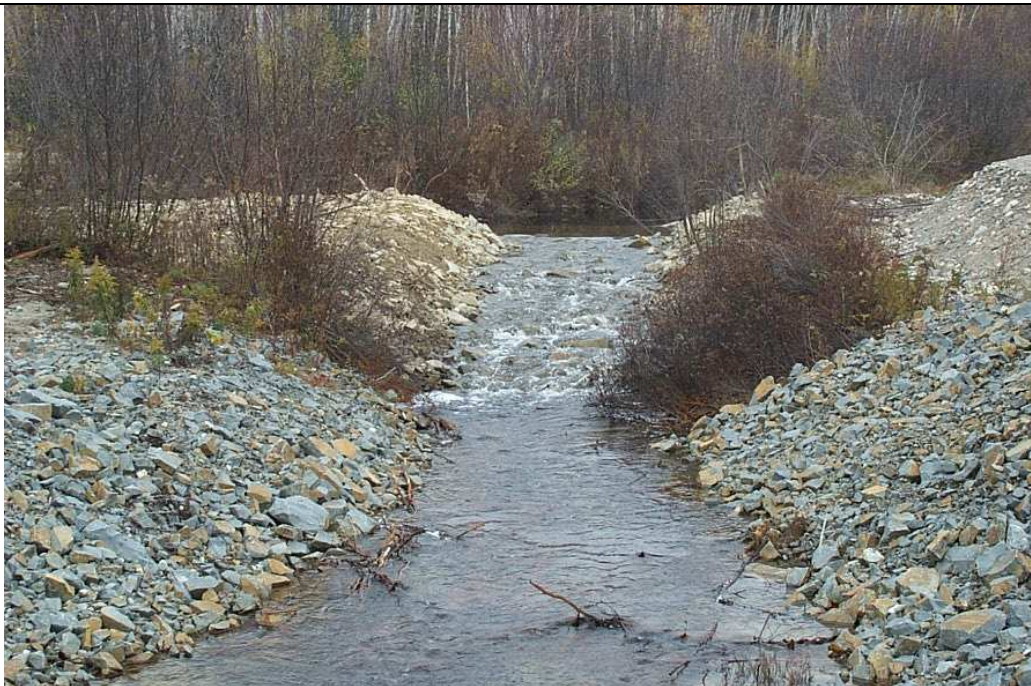
Photo 2: Looking upstream towards cofferdam

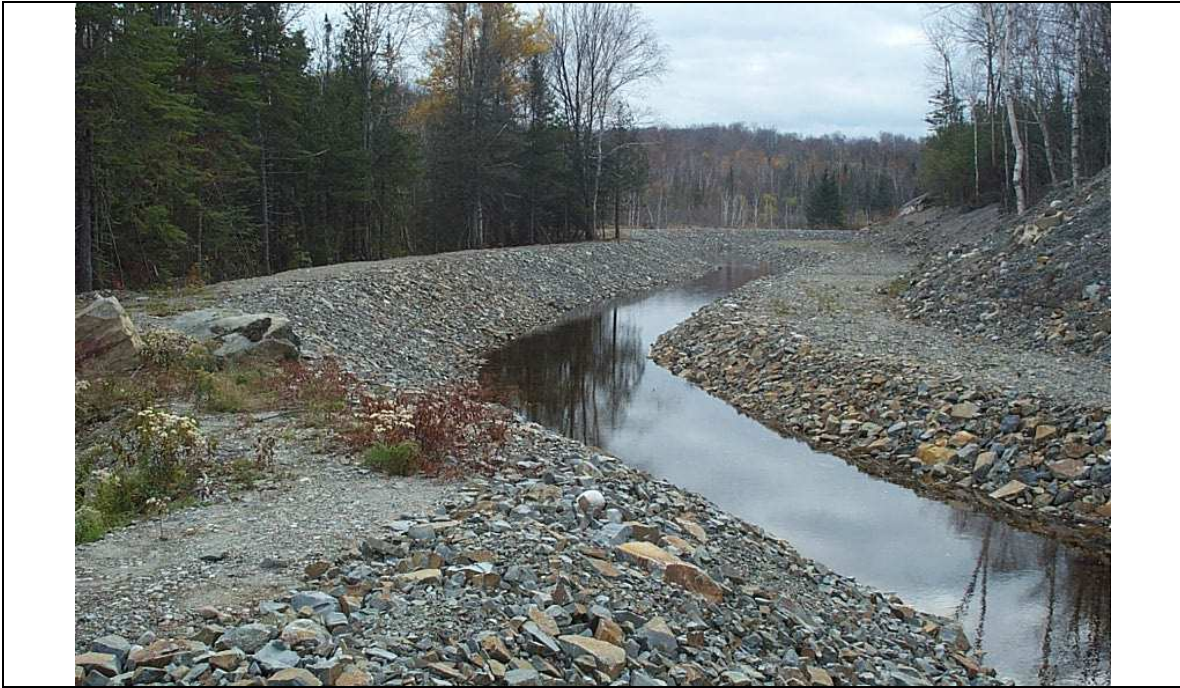
Photo 3: Buckles Creek Channel looking from Nordic Road.

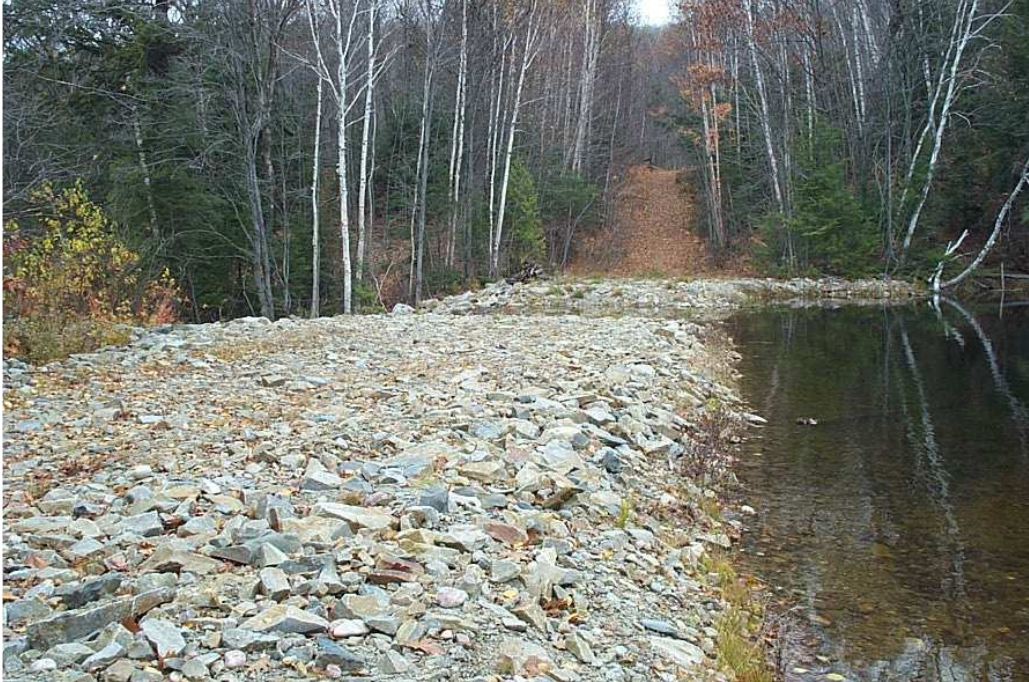
Photo 1: Upstream view of Westner Lake Outlet Berm

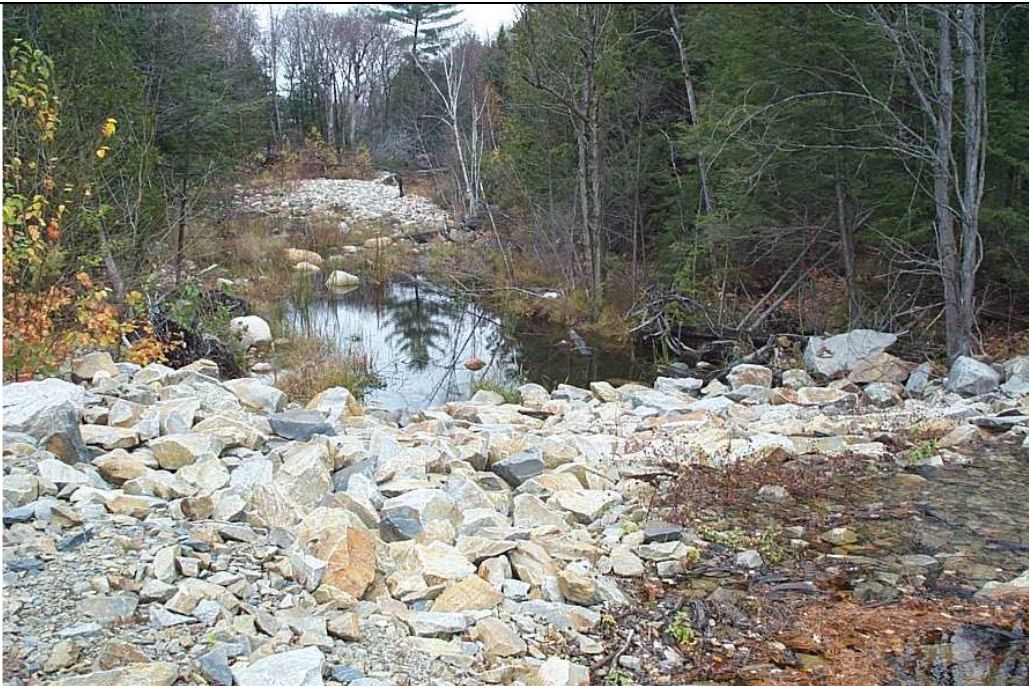
Photo 2: Rip rap lined spillway

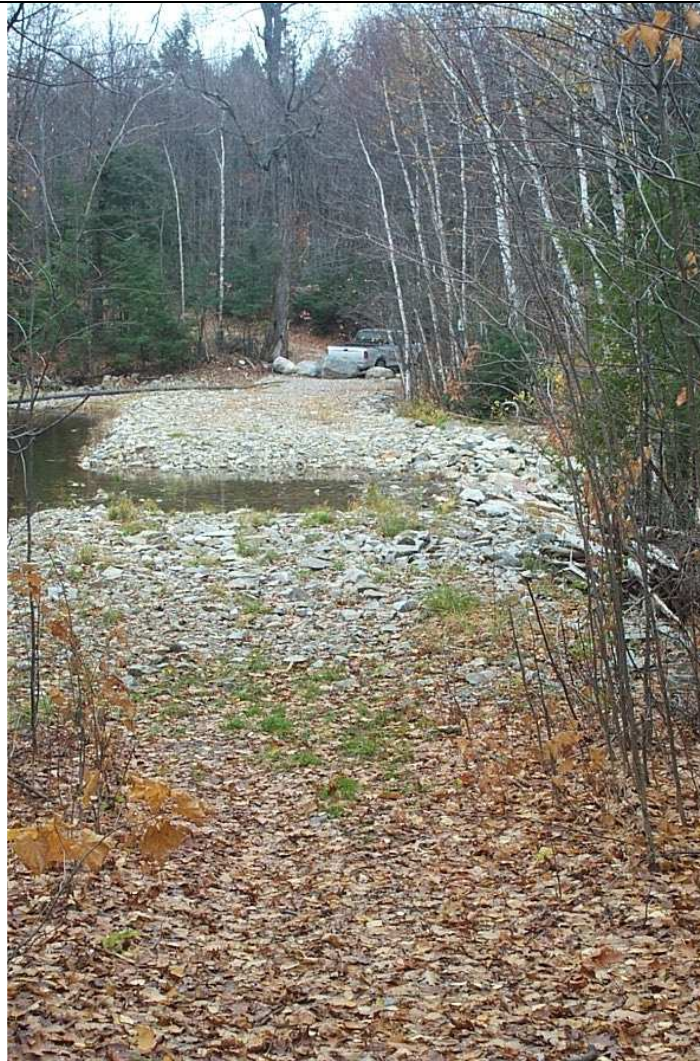
Photo 3: Water overflowing spillway on crest of dam
